SERVICE INFORMATION LETTER SI 01.02

Machines/Models: WIDE SERIES X MODEL **Serial Numbers:** Above 6012

PURPOSE: Inspect the Pivot Bolt in the Brake Linkage.

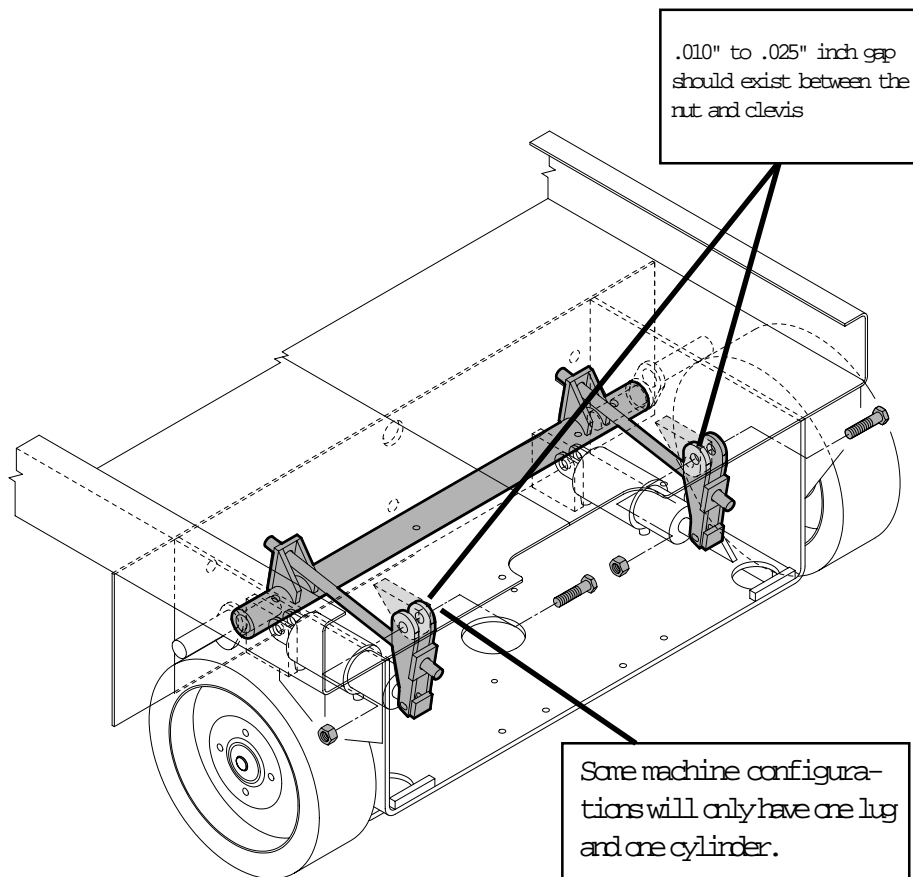
PROCEDURE REQUIRED: Verify that the Pivot Bolt for the Brake Linkage is not Overtightened.

1. The 3/4" bolt in Figure 1 should not be torqued, verify that a gap of .010 to .025" exists between the nut and the side of the brake adjustment weldment.
