# SERVICE BULLETIN SB00.04

**Machines/Models:** SB80

**Serial Numbers:** 1337-1436

**PURPOSE:** Enhance the performance of the Master Leveling Cylinder

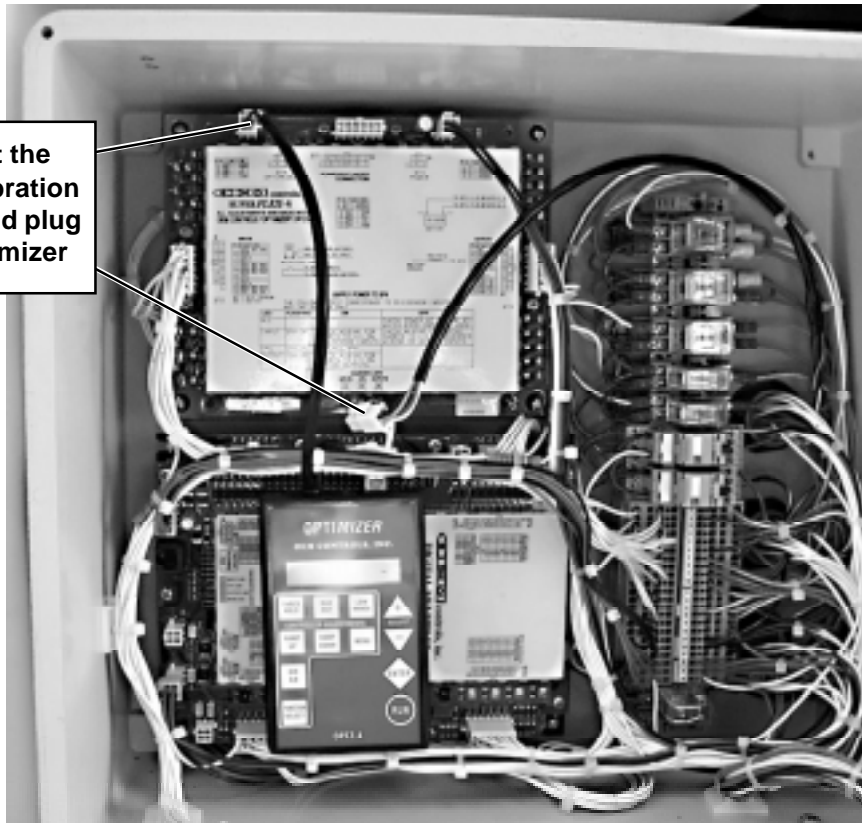
**Figure 3**

Disconnect the  
upper calibration  
harness and plug  
in the Optimizer

1. Disconnect the upper calibration harness.
2. Plug the Optimizer into the Super Flex (see Figure 3).
3. Operate Lift Down function. The Optimizer will display each setting.
4. If the function is out of adjustment, use the plus and minus adjustment keys on the Optimizer to reset to the proper setting.
