Service Bulletin: AB38

Reference: SB07.07

Affected Machine: **AB38**

Part Affected: Inner boom to transition welding

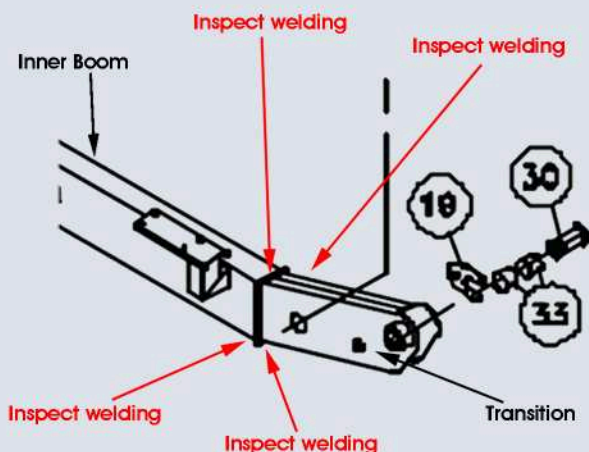
Our Quality team has uncovered a potential problem with welding on the AB38 teleboom, where it meets the transition. As a precautionary measure, all UpRight AB38 lifts should be inspected at the earliest opportunity but within 7 days at the latest.

We advise you to inspect all the welding on the teleboom in the area of the transition as indicated on the diagram below. This is in line with PRE Operation Safety Instructions to be found on Page 5 item 7 of the operators manual which states:

If you discover any weld issues, please contact the **UpRight Product Support Team**. Please remember to provide us with the machine's complete **Serial Number** and **photographs** of the affected area.

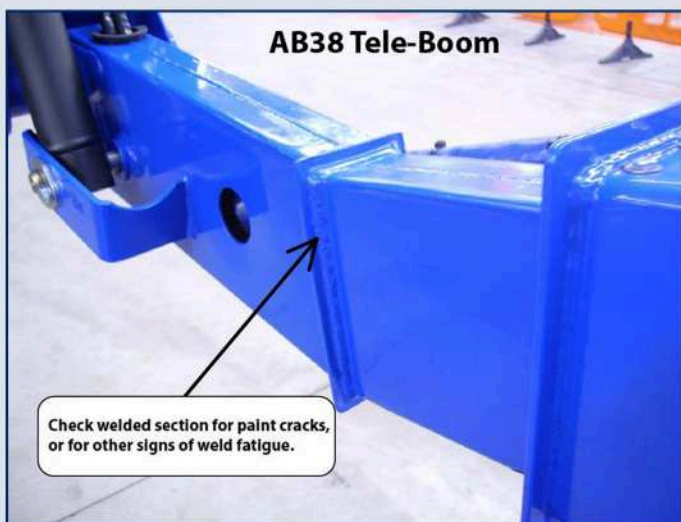
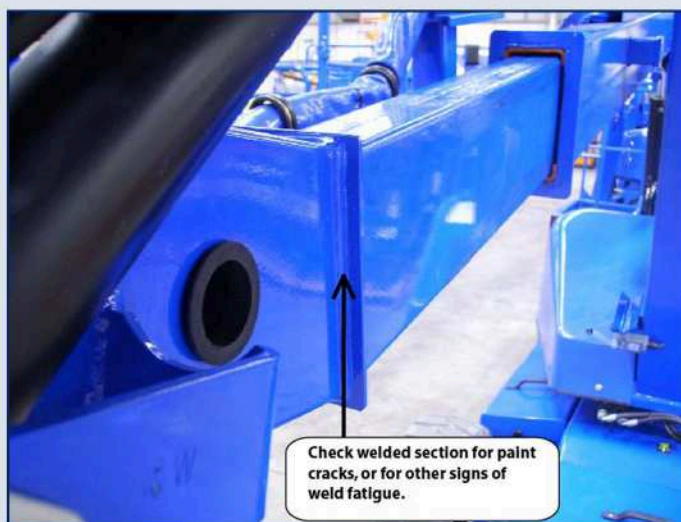
"Inspect the weld on the plate welded to the inner boom and the transition for any signs of: cracks or lifting of the weld from the parent metals. If in doubt, the paint should be removed and inspected with either chemical crack-testing solvents, or with ultra-sound equipment to give the welds."
