Service Bulletin: UL Series (UL25; UL32; UL40)

Reference: SBU10.01

Date of Issue: 11th January 2010

### Affected Machines: **UL Series 220V AC** Serial Numbers: 31089 - 31407

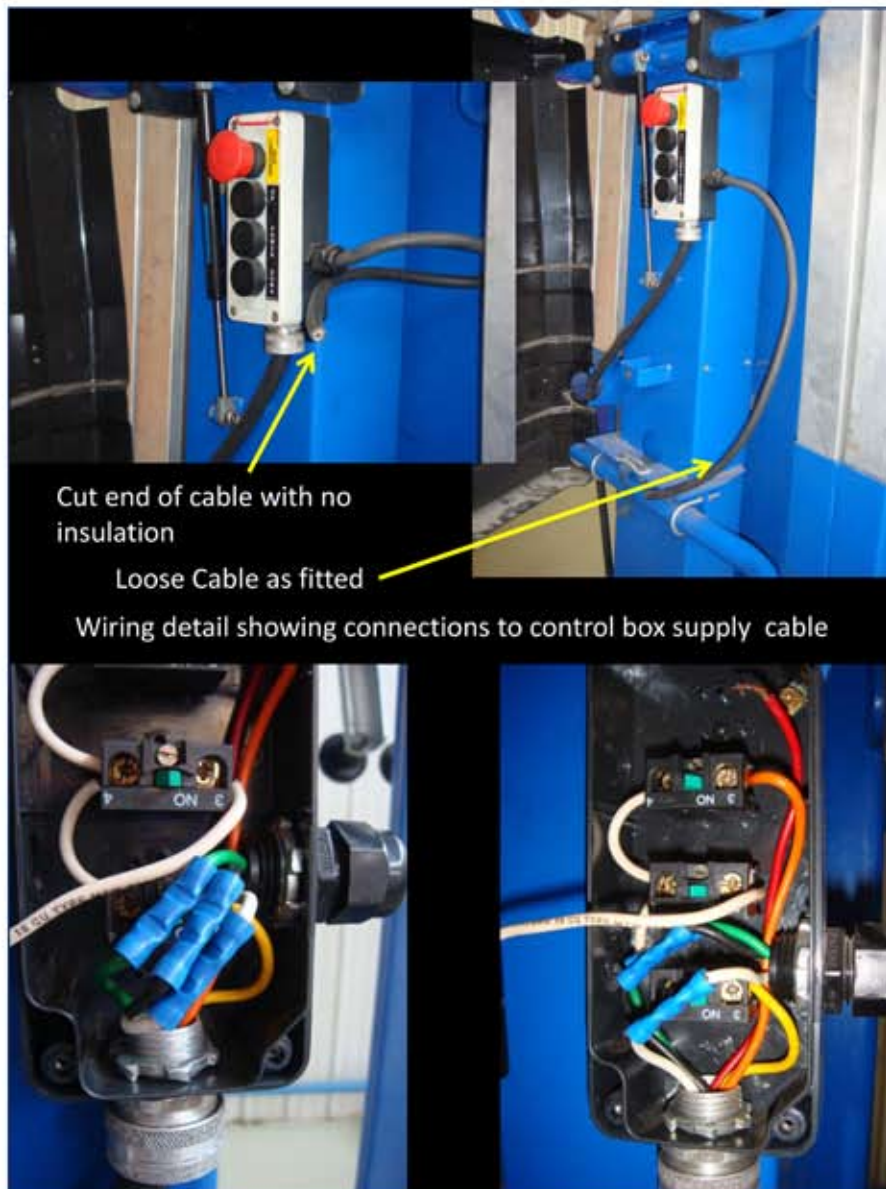
The power to platform option is provided by a 'flying lead' which has one end terminated in the platform control box (photographs below). The other end of the lead is provided as a customer option which can be terminated using an electrical socket which is appropriate for the region in which the machine is being used.

We have found examples where the user end of the cable has not been terminated or insulated resulting in the cut ends of the cable being electrically 'live', with the potential for an electrical shock hazard.

- 1) Ensure that the machine is switched off and disconnected from any electrical power source.
- 2) Confirm whether the power to platform flying lead has already been terminated to an electrical power socket (by customer option)
- 3) Unless an electrical power socket has already been fitted to the power to platform flying lead then one of the following options should be implemented by a suitably qualified technician to rectify this issue.
  - a. Terminate the flying lead using an approved electrical power socket which is appropriate to the region in which the machine is being used.
  - b. Disconnect and remove the flying lead by removing the terminations of the lead from the blue in line crimped connectors inside the control box (see pictures). It is then most important to ensure that the cable connections remaining in the control box are fully insulated.
