Service Bulletin :  
XRT Manual Platform Lower

Reference: SBU10.06

### Affected Machines: XRT Series

**Serial numbers: 10000 to 10150**

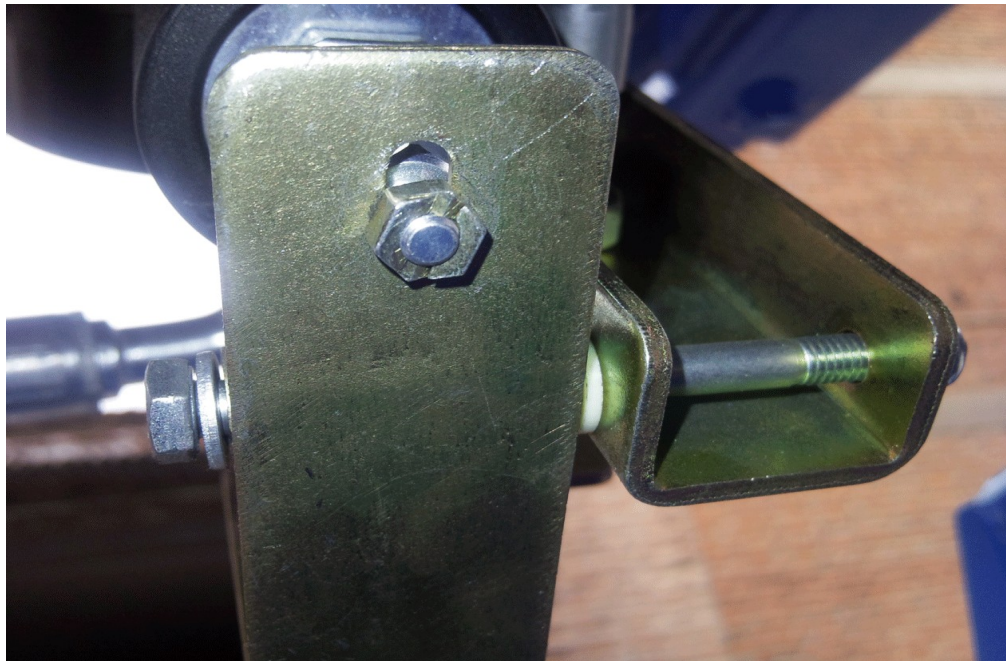
**Purpose:** The manual platform descent handle for the XRT range of machines, operates a mechanism which is attached to the bleed down valve of the lift cylinder. The lever mechanism attached to the end of the bleed down valve is secured by a 'Binx' nut (see picture below). It has been identified on a machine in service that the Binx nut had become loose resulting in non or unreliable operation of the manual lowering function.

A modification has been introduced for new build machines, where the Binx nut has been replaced using a number 10 UNF 'Nyloc' nut with the addition of 'Loctite 243' threadlocker fluid.

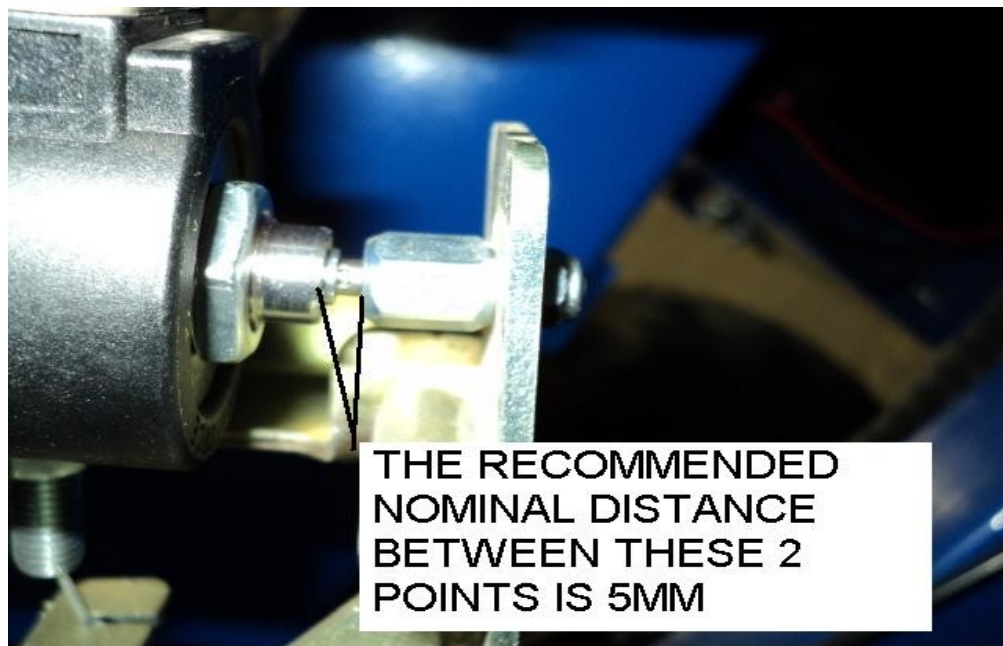
**Procedure:** The bleed down mechanism should be examined to determine whether a Binx type nut is present. If so then this nut should be replaced using the number 10 UNF Nyloc nut along with the application of the threadlocker solution. It should be noted there must be a set gap between the body of the bleed down valve and the barrel nut behind the actuator lever (see picture below).

After replacing the Binx nut the operation of the mechanism should be checked to ensure that the bleed down valve operates correctly from the manual lowering cable handle.
