Service Bulletin: Aerial K13 Trailer mount access platform

Reference: SBU08.02

Date of Issue: 19th February 2008

### Affected Machines: Aerial Access K13 Trailer Mount Manufacturing date: Pre Jan 2003

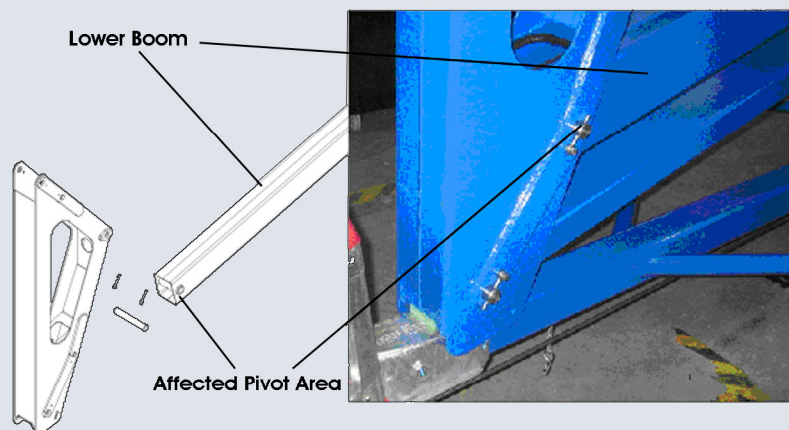
It has been reported that cracking of the welds can develop around the pivot tube of the bottom boom section. This can cause structural failure of the pivot point and surrounding boom section at the towing end of the bottom boom (see pictures and diagrams below).

The bottom boom section must **immediately** be inspected in the areas indicated to detect any degradation of the pivot tube welds at the towing end of the bottom boom, or any indication of degradation of the boom fabrication around the pivot point.

**If any degradation of the indicated area is found then the machine must be removed from service immediately.**

- 1) Immediately carry out inspection of the boom section and associated pivot boss welds as indicated.
- 2) If any degradation of the indicated area is found then the machine must be removed from service immediately
- 3) Inspection findings should be reported to the contacts below to confirm that the appropriate action is being taken.
- 4) Even if no degradation is found during inspection, replacement of the boom should be carried out within 90 days. (The procedure for replacement of the boom section is attached to this bulletin)
- 5) The replacement boom should be ordered through the Upright spare parts department (+44 (0) 191 461 6910)
