Service Bulletin : X Series Motor
Mount Weld

Reference: SBV 11.08

Date of Issue: 19th October 2011**Affected Machines: Snorkel / Upright X26N, X26, X32****Serial Numbers:**
X26N 51172 to 51200
X26 53251
X32 53250**MANDATORY MACHINE INSPECTION AND WELD REPAIR TO BE CARRIED OUT
IMMEDIATELY**

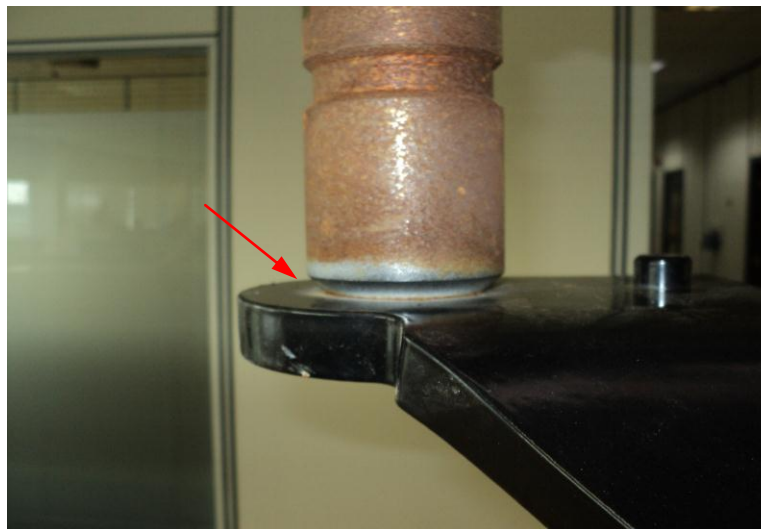
A quantity of left and right hand drive wheel motor mounting fabrications have been manufactured by our supplier with a structural weld fillet missing. The main steering spindle (Kingpin) must be welded to the top of the motor mount plate and this weld fillet has been omitted as shown below.

Action: It is mandatory that the X Series machines identified in the serial range above must be inspected upon receipt of this bulletin to confirm whether the weld fillet indicated is missing.

If this is the case then the machines must be removed from service immediately and not returned to service until a weld repair has been carried out.
