SERVICE INFORMATION LETTER SI 01.01

Machines/Models: X20N

Serial Numbers: Above 6012

PURPOSE: Inspect the Pivot Bolt in the Brake Linkage.

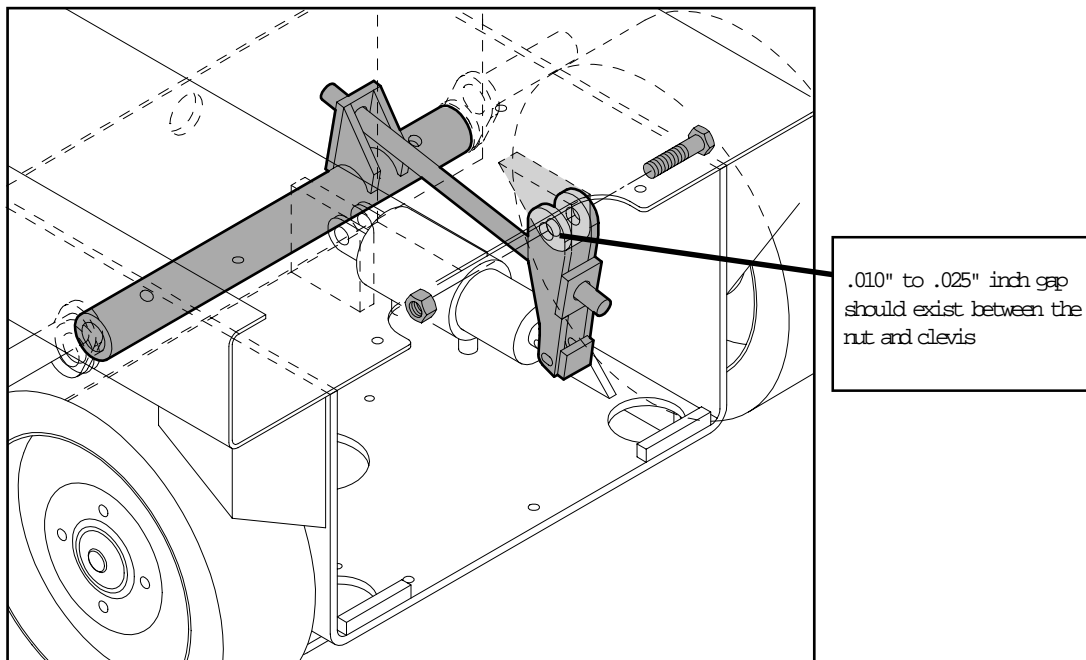
1. The 3/4" bolt in Figure 1 should not be torqued, verify that a gap of .010 to .025" exists between the nut and the side of the brake adjustment weldment.
