# SERVICE BULLETIN SB98.19

## Machines/Models: MX15/19

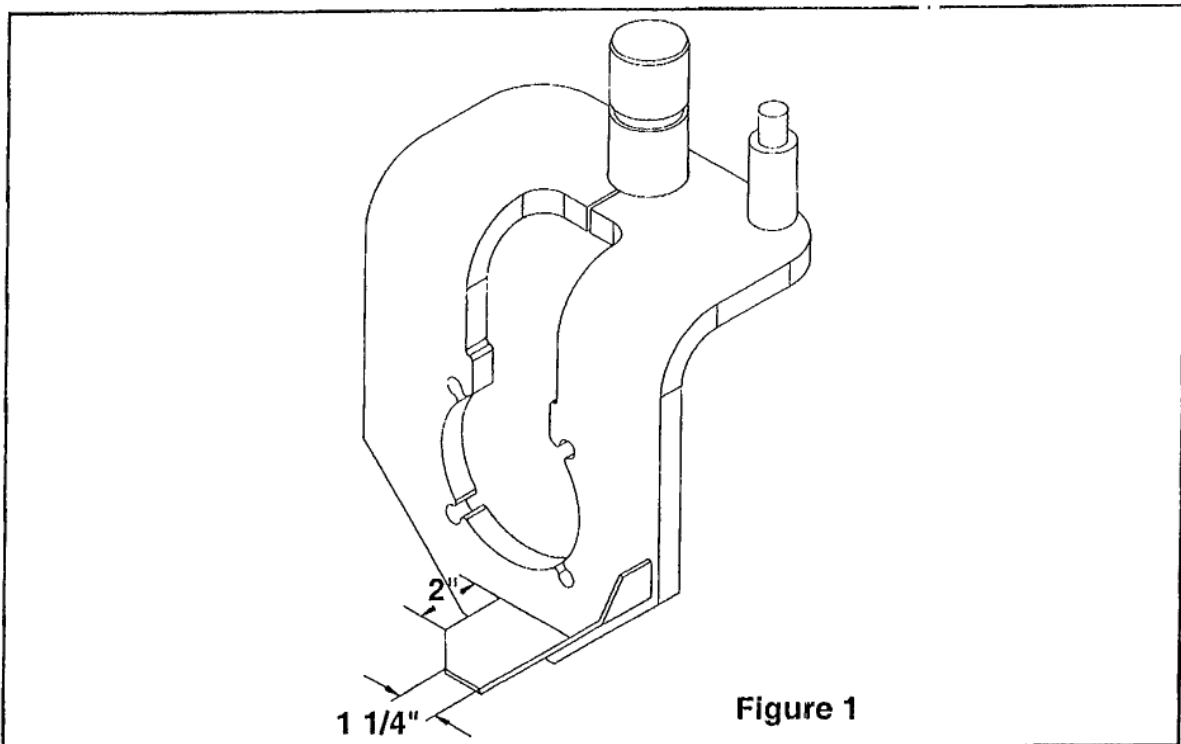
**Serial Numbers:**8791-9379, 9381-9549, 9553-9570  
9572-9598, 9602-9687, 9691-9694,  
9698-9708, 9714-9730, 9732-9733, 9759**THIS BULLETIN IS MANDATORY.****DATE:** October 12, 1998**PURPOSE:** To provide additional clearance between the drive motor guards and the pothole protection bars.**OPERATION REQUIRED:** Remove material from motor guard as indicated below.**REIMBURSEMENT:** UpRight will reimburse the owner of record for up to 1/2 hour of labor at \$35.00 per hour and for travel (up to 100 miles) at \$0.25 per mile. Reimbursement will be made upon receipt by UpRight of your completed warranty claim form. Please reference SB98.19 on your warranty claim form.**PROCEDURE:** Read all instructions thoroughly and refer to figure 1 before starting. Platform must be in stowed position on a firm level surface.

1. Using the upper controls, turn steering wheels to full left.
2. Using an oxygen/acetylene cutting torch or equivalent cutting device remove the area off the aft corner of the left motor guard, as shown in figure 1.
3. Using the upper controls, turn steering wheels to full right.
4. Repeat step 2 for the right motor guard.
