SERVICE BULLETIN**SB00.30****Machines / Models: MB20/26****THIS BULLETIN IS MANDATORY.****DATE:** 26, September, 2000.**PURPOSE:** To remove the risk of damage to the main harness cable by the action of the mast movement.**OPERATION REQUIRED:** To fit a replacement trunking cover by following the procedure detailed below.

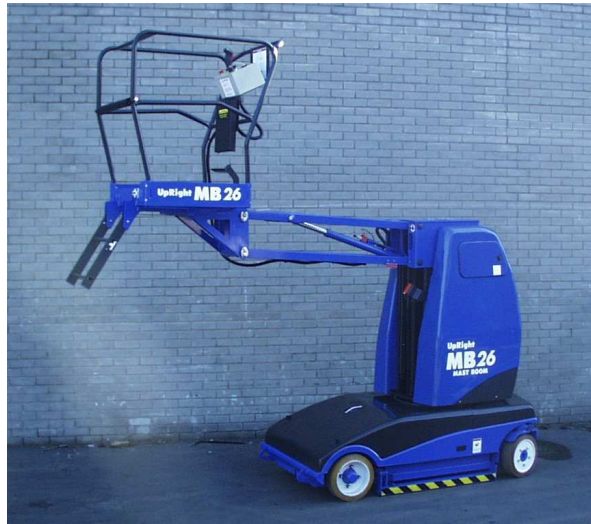
1. Ensure that mast is brought to its fully lowered position.
2. Using the lower control box raise the jib until the jib members are horizontal as shown.

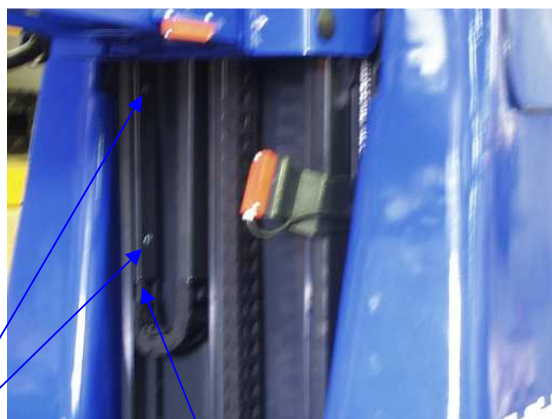
Countersunk
Bolts

Cover to be removed

3. Remove the key from the lower control box and press in the emergency stop.
4. Using a 5mm Allen key, remove the two countersunk bolts shown below. The old trunking cover can now be removed. The trunking cover in question is the one closest to the lower control box side of the machine. Discard old trunking cover in an environmentally friendly manner.
